Manhole Inspection Summary

Manhole # S33A__046MH

Location Address: **WASHINGTON PL** Cross Street: **MT VERNON PL**

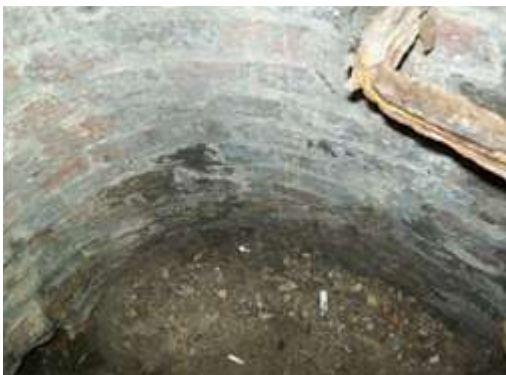
Defect 3

DEBRIS ON CHANNEL

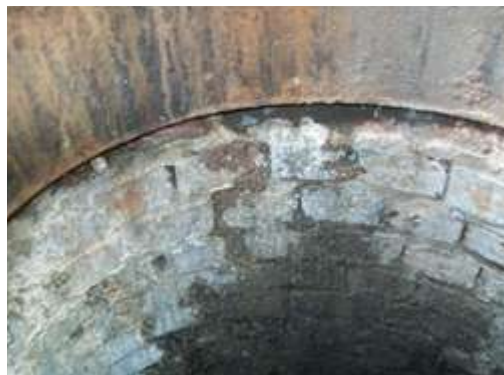
Defect 2

Frame Offset: **0** (in.) Condition: ☐ Sound ☐ Cracked ☒ **Leaks**

2" GAP BELOW FRAME. EVIDENCE OF INFILTRATION DUE TO SHEETING - FRAME LEAKS

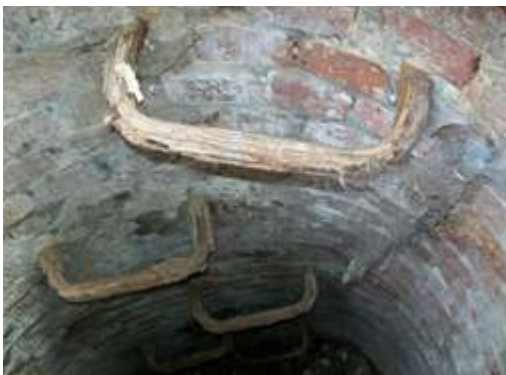
Defect 1

Steps Count: **5** Missing: **0** ☒ **Corroded**

CORRODED STEPS

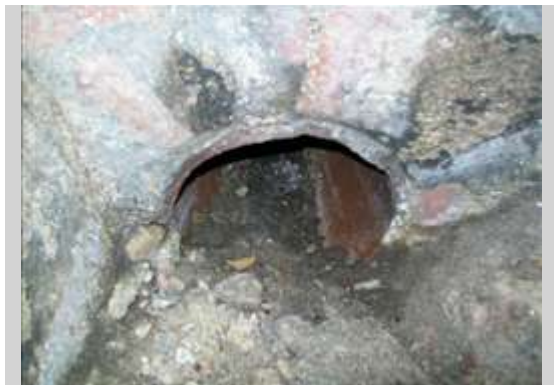
12 O'Clock Outflow

Deposits: ☐ None ☒ **Mud** ☐ Sludge ☐ Debris ☐ Grease

Silt Depth: **1** (in.) Deposits Extent: **Light**
